Division of Oil, Gas and Mining

Inspection Report Minerals Regulatory Program August 25, 2010

Mine Name: Southern White/ Mountain Rose	Permit Number: S/001/0047
Operator Name: Great American Resources, LLC	Inspection Date: 06/23/2010
Inspector(s): Brett Gregory for Tom Munson <u>B</u>	Time: 10:30 am
Other Participants: None	Mine Status: Active

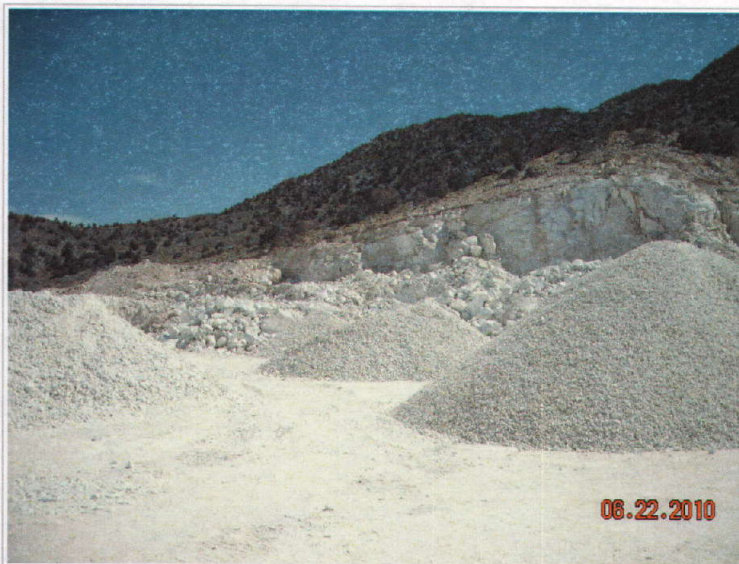
Upper pit with crushed limestone.

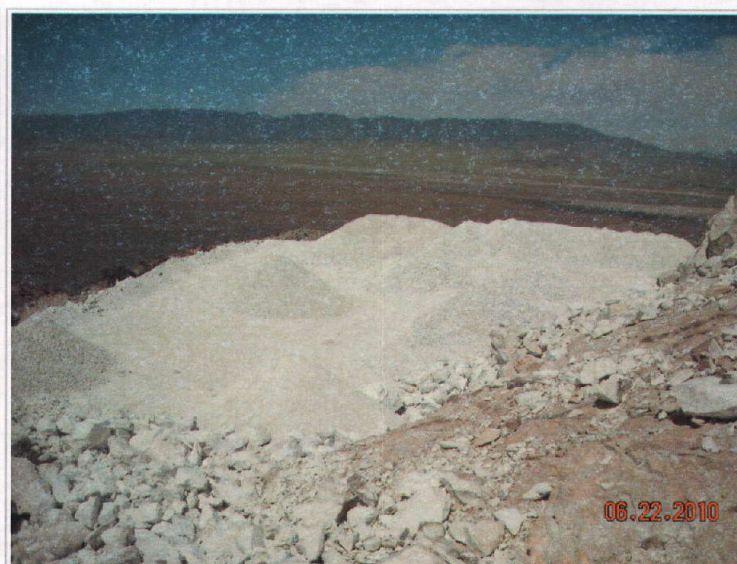
Top of highwall looking down on upper pit.

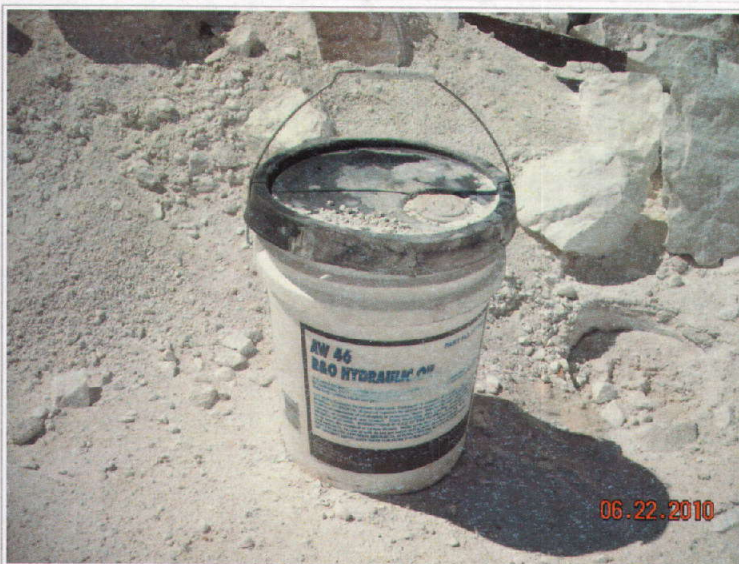
Oil container.

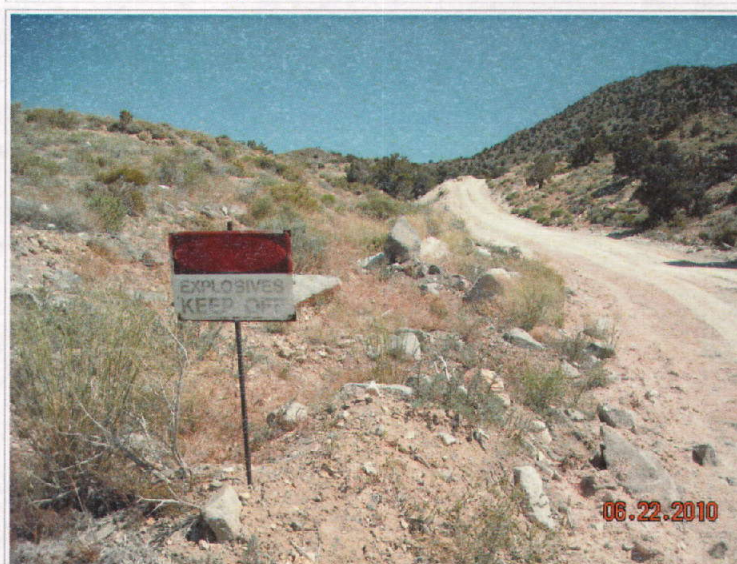
Mine road joining the lower and upper pits.

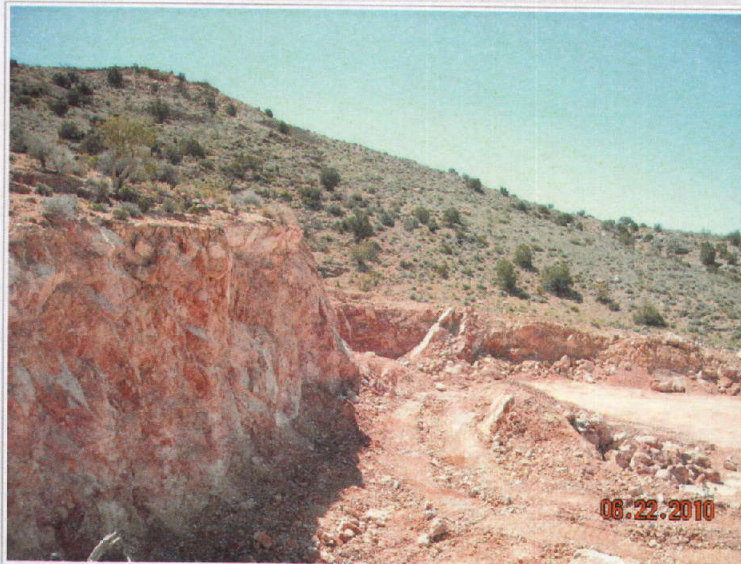
Jointed limestone and highwall of the lower pit.

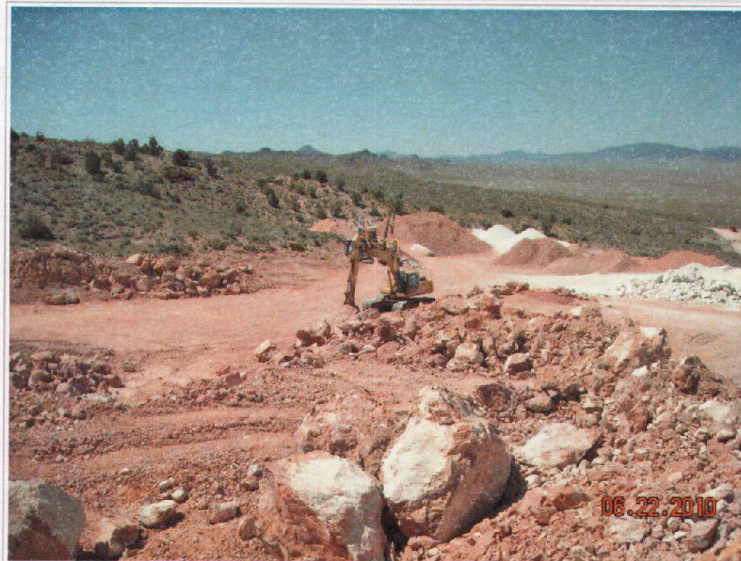
Working surface of lower pit.

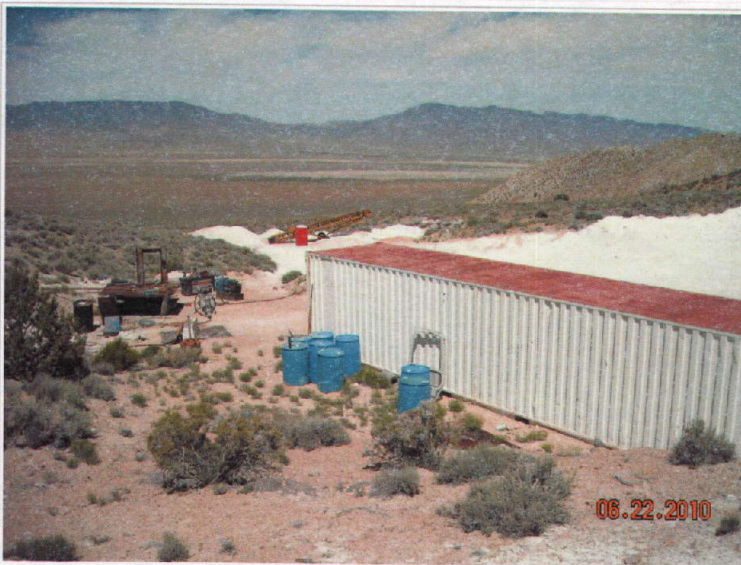
Semi trailer with unknown barrels.

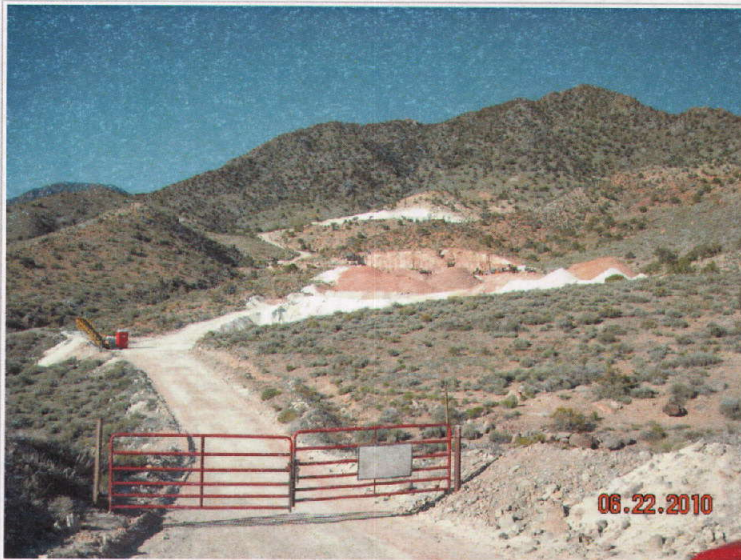
Access gate.

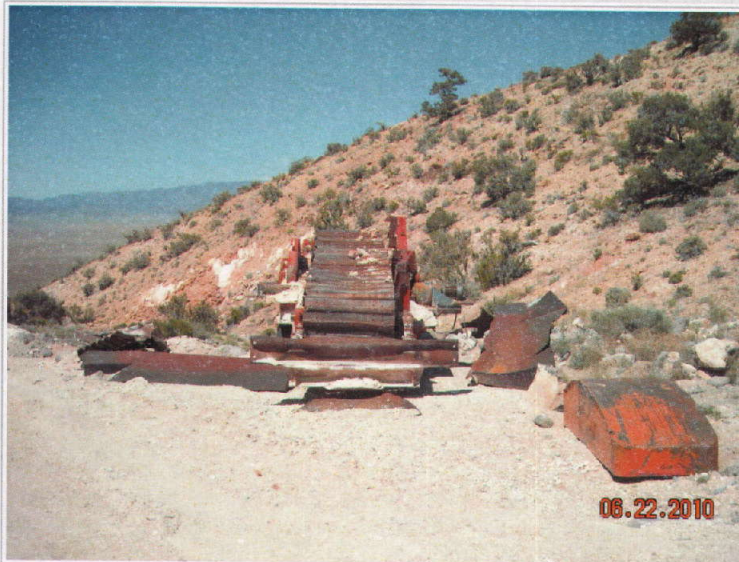
Dilapidated mining equipment.

1. The reclamation bond needs to be escalated from the current \$18,600 to \$33,800 in order to account for a minimum of seven acres disturbance. The operator should contact lead Penny Berry of the Division to work out the surety requirements for this site.
2. Dilapidated mining equipment and related garbage should be removed to a landfill or salvaged for scrap iron.
6. Concurrent reclamation may reduce the amount of surety required and help to maintain a disturbance footprint consistent with that of a small mining operation.
12. Photographs and a GPS map are attached documenting the conditions of the mine.

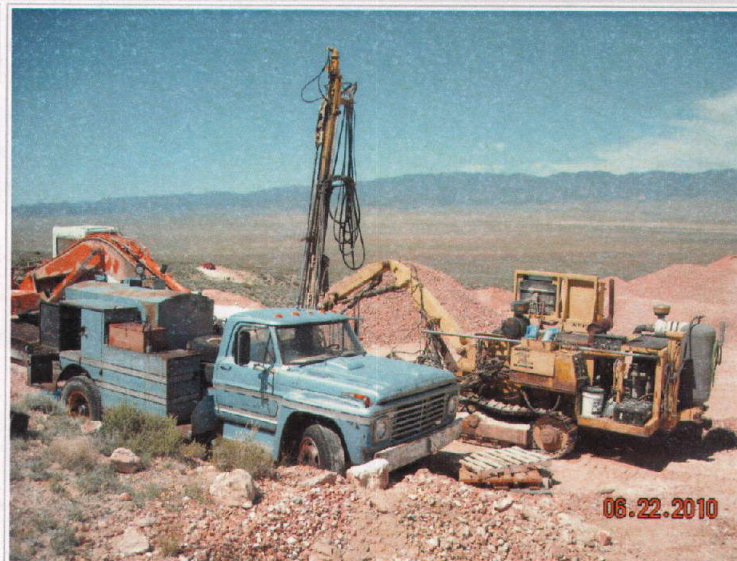
Mining equipment.

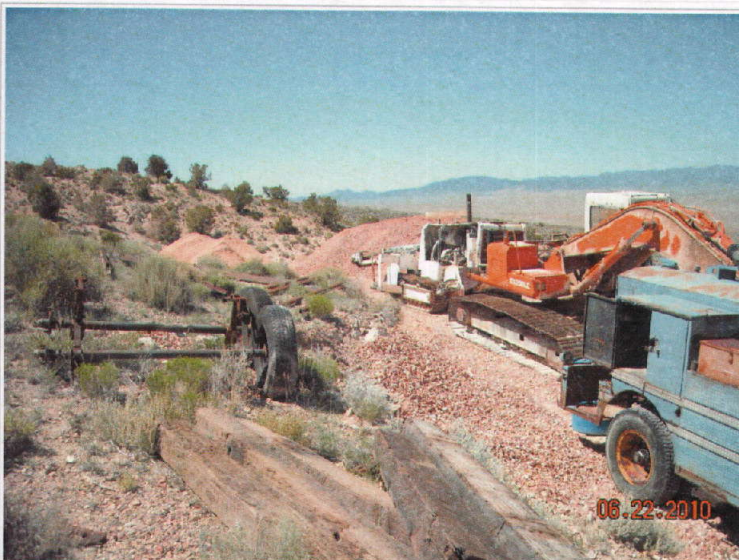
Minor garbage.

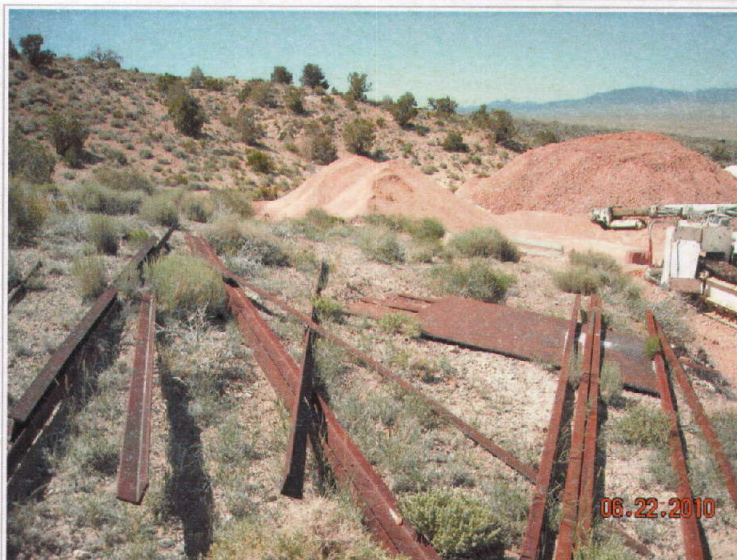
Scrap iron.

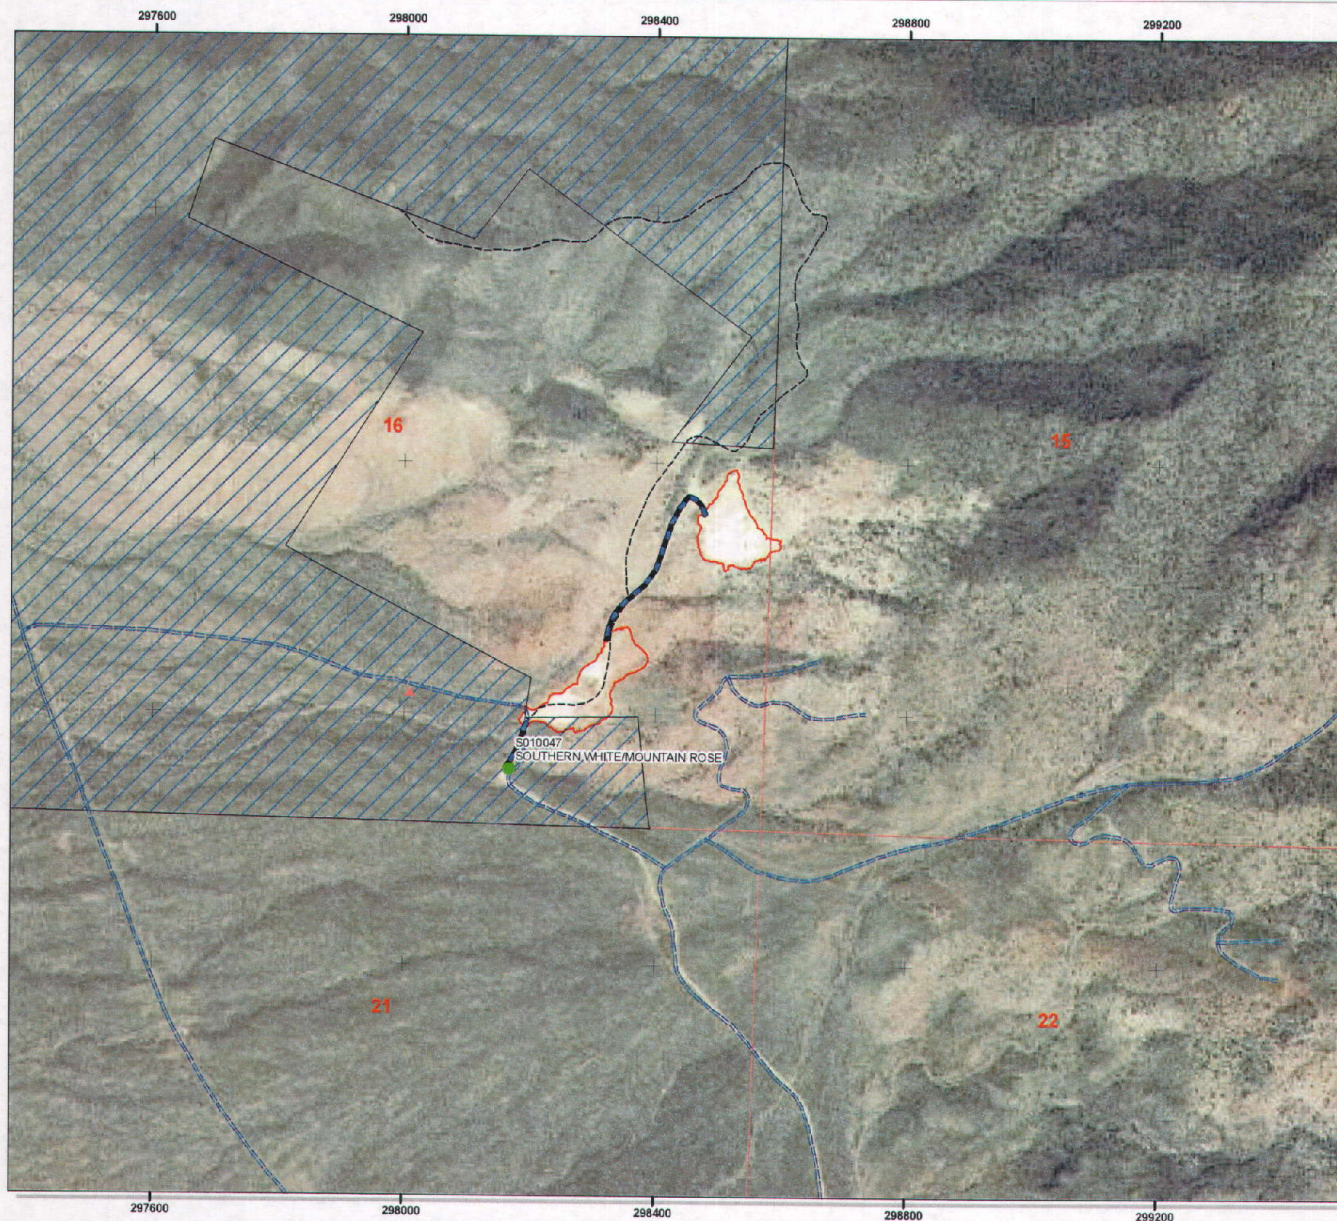
Mine Number: S010047
Mine Name: SOUTHERN WHITE/MOUNTAIN ROSE

The newly created GPS map indicates the mine is larger than what is allowed for a small mining permit. The operator needs to file for a large mining operation (LMO) and upgrade the current reclamation bond to account for the increase in size of the mining area.

Acres Disturbed	6.0
Acres Regraded	0
Acres Seeded	0
Road Acres Disturbed	0.43

Total Acres Disturbed	6.43
------------------------------	-------------

The operator needs to file for a large mining permit and post an adequate surety for the actual disturbance on the ground. The current surety should increase by the amount of \$15,200 dollars. The large mining permit application may be obtained by contacting the surety coordinator (Penny Berry) at 801-538-5291. The Division will continue to monitor the site when in the area.
